R O S E T T A
FLIGHT REPORTS
of RPC-MAG

RO-IGEP-TR-0015

Anomaly Report & Analysis

MAG-OB Failure in June 2005

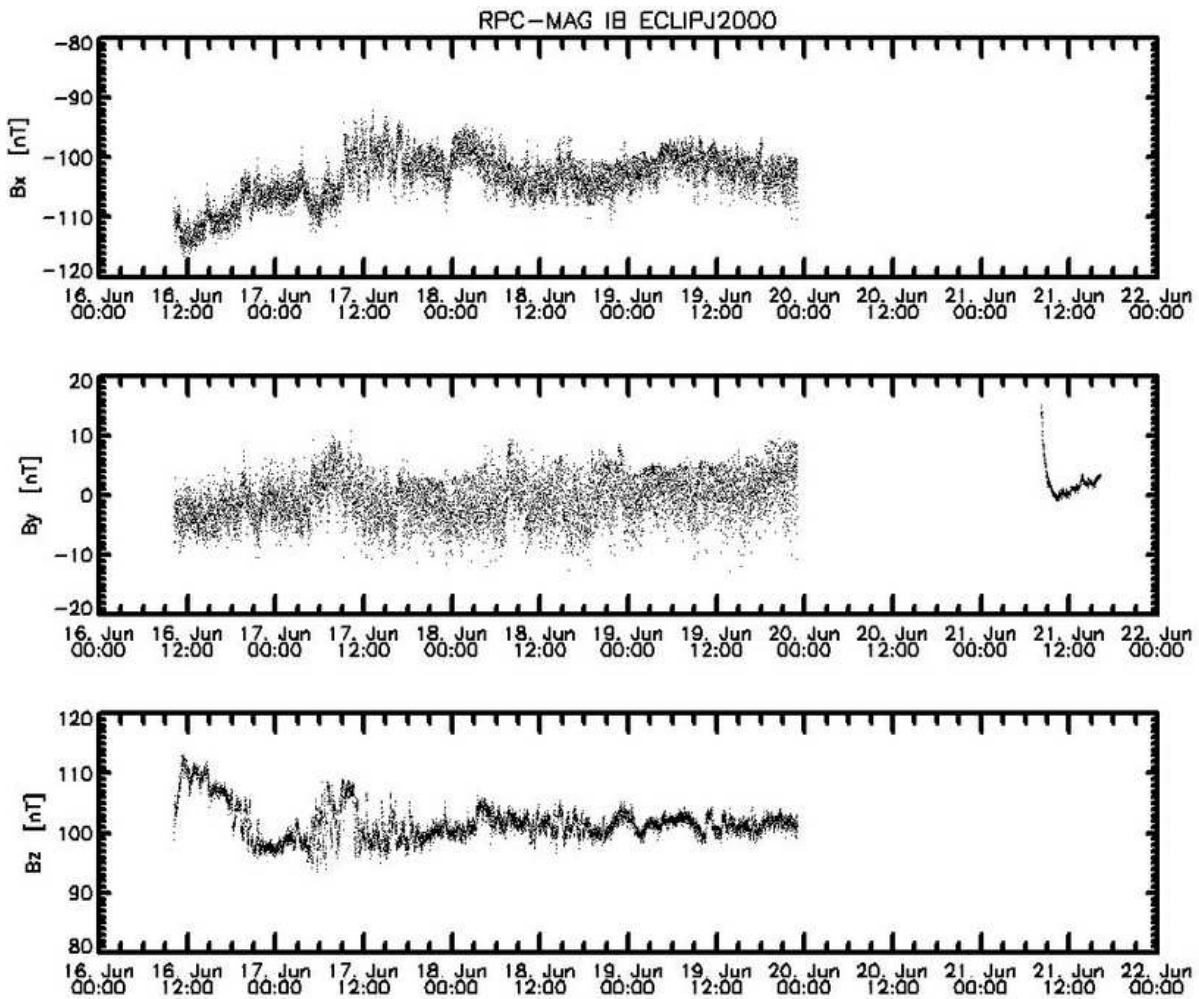
Figure 2: RPCMAG: Magnetic field measured with the IB Sensor

On the first view everything looked nominal. According to our HK data all necessary voltages had the right values (refer to the plots in Appendix B) and the RPC-MAG IB sensor transmitted reasonable data in the usual manner (refer to Figure 2). The OB sensor, however, sent a faulty signal (refer to Figure 3):

The increased noise level of the IB sensor is caused by the variations of the OB-Y sensor with an amplitude of some thousand Nanotesla. Both sensors are only 15 cm apart. Therefore, the huge OB-Y variations have a magnetic influence to the IB sensor in the order of some Nanotesla.

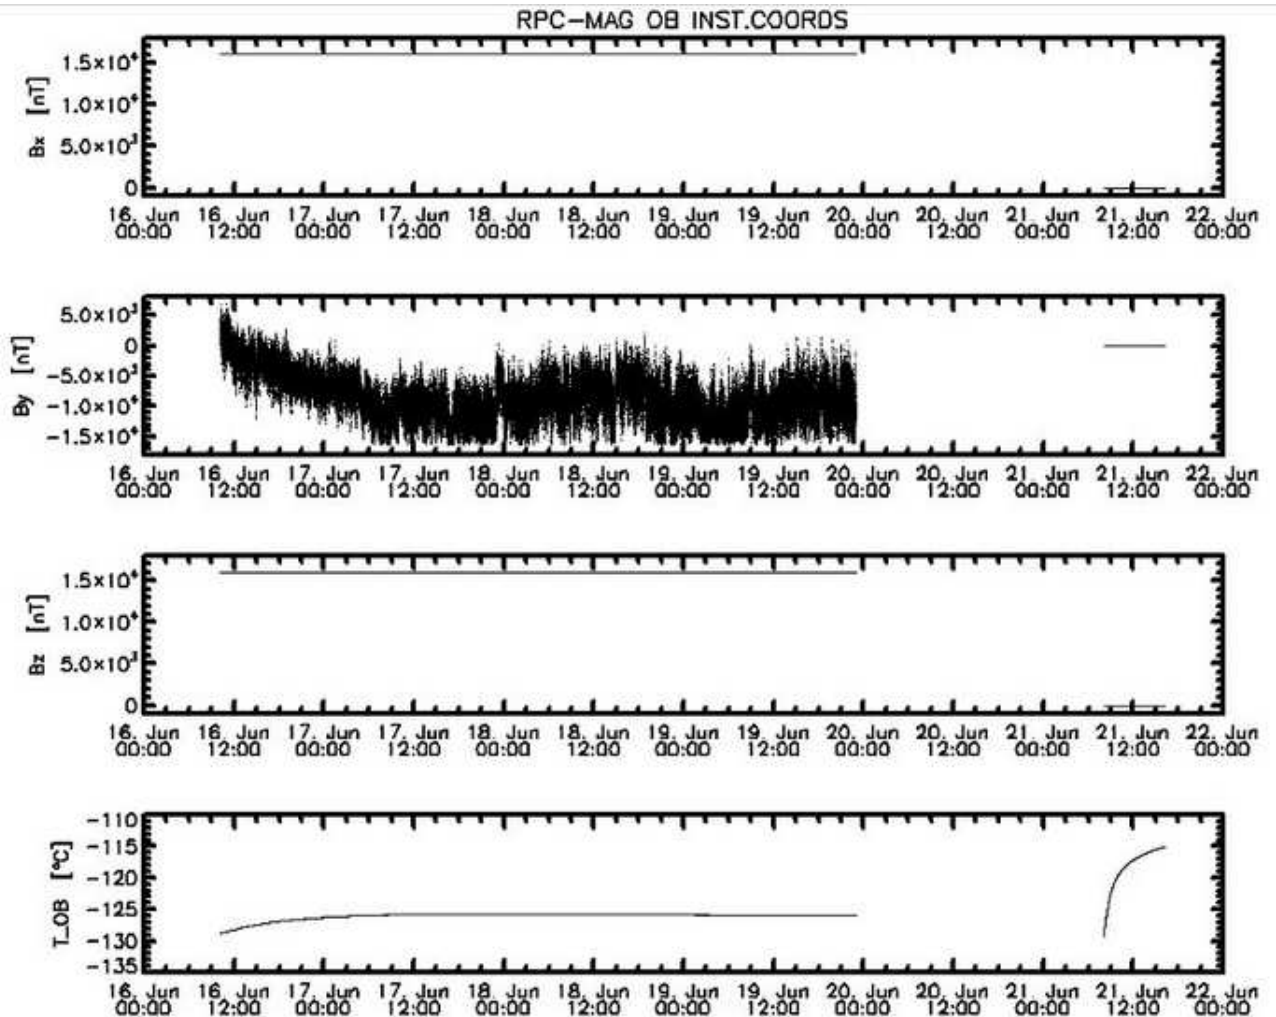
Figure 3: RPCMAG: Magnetic field measured with the OB Sensor

- the B_x component was permanently saturated.
- the B_y component showed erratic variations of a few thousand Nanotesla.
- the B_z component was permanently saturated.

This behavior did not change over the whole operation period until the switch off on June 19. The OB data looked erroneous in the science packets (sampled by 3 individual 20 bit ADCs) and the housekeeping packets (sampled by a different 16 bit ADC) as well (refer to Appendix C). The temperature of the IB and OB sensor (thermistors inside the magnetic field sensors) was, however, measured in the right way (refer to Figure 17).

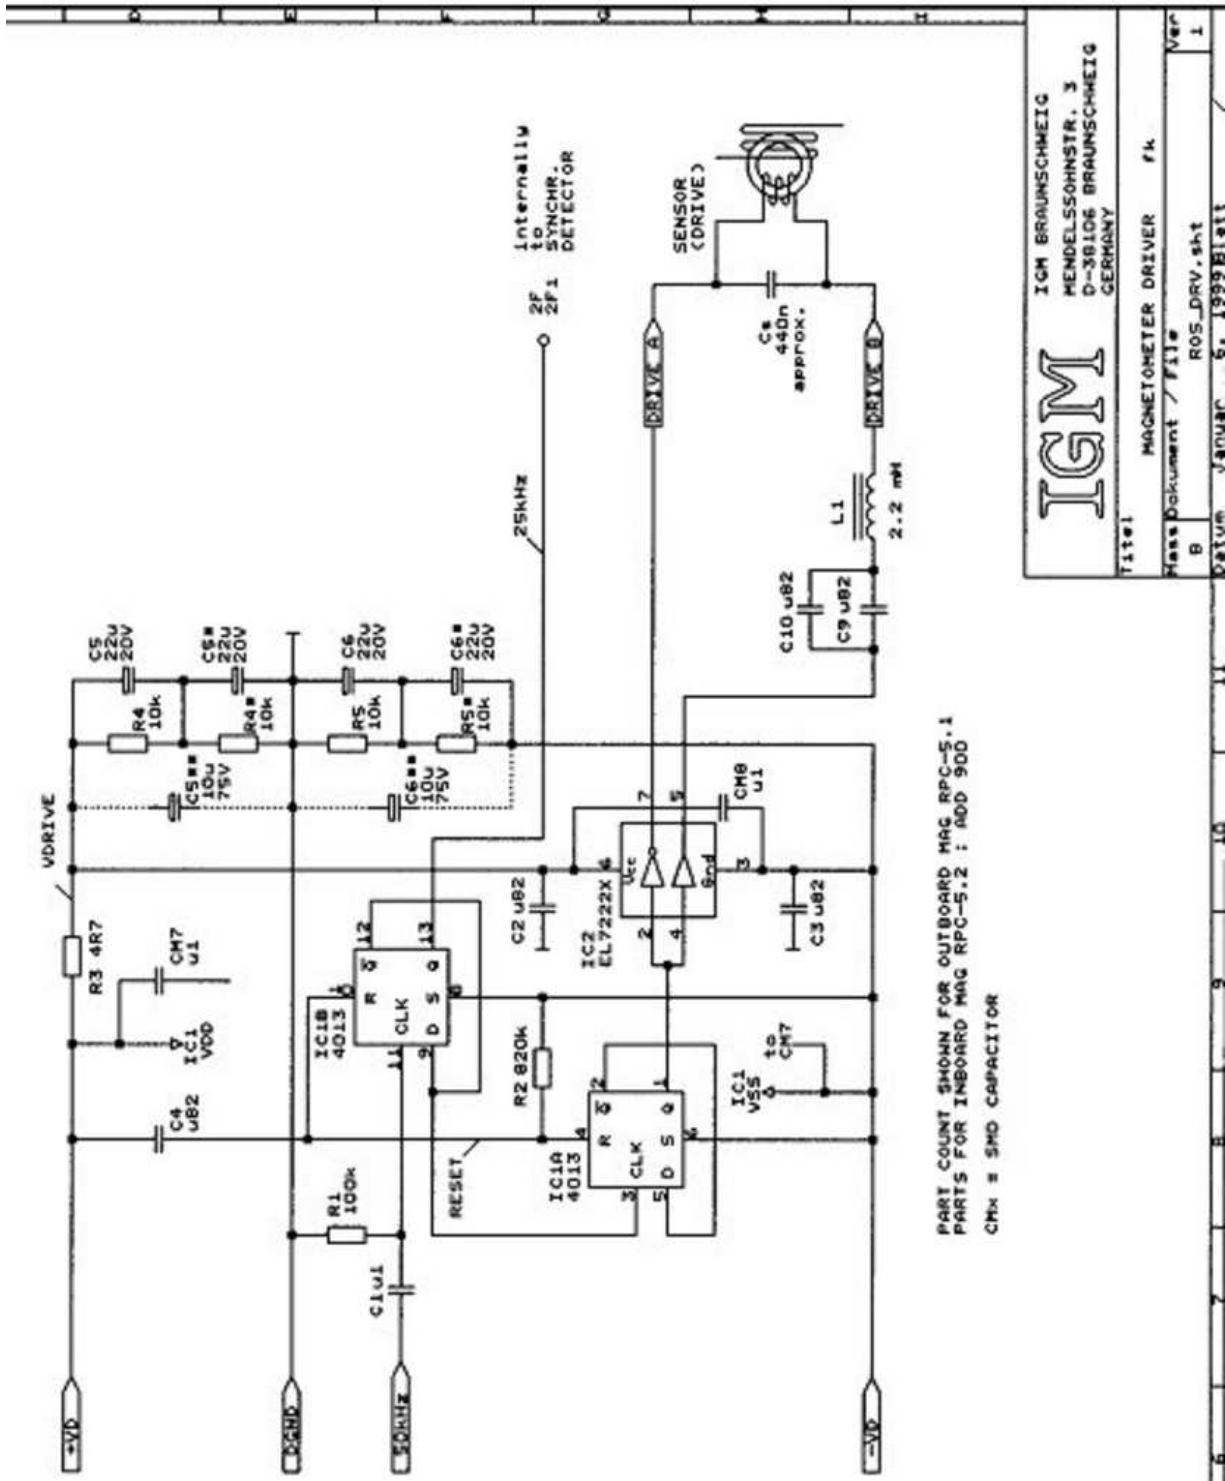
Figure 16: RPCMAG Driver Electronics

- The master clock f_0 is divided by 84 to generate an input frequency of $f_1 = 50$ kHz for the FGM drive electronics (refer to circuit diagram in Appendix E). Furthermore this frequency is divided by 2 times 2 to provide the needed $f_2 = 25$ kHz and $f_3 = 12.5$ kHz. Thus, up to this point the failure probability is extremely low.
- The most likely failure source is the complex behavior of the resonant circuit consisting of L_1 , C_s and the sensor excitation coil (refer to the right side of Figure 16) during the power on phase.

The described resonant circuit has to oscillate exactly on his resonance frequency of 12.5 KHz. This can only be guaranteed, if during the RPCMAG activation phase enough power is provided via the s/c or RPC PIU power supply. It is absolutely necessary that the supply voltage rises "immediately" with a steep flank. If the flank is to flat, respective the slew rate is to slow, the resonant circuit is not able to draw the high initial current needed to fall into the right oscillation state (the resonant circuit is not excited with a simple sinusoidal signal but with steep needle pulses to minimize power consumption. Therefore, sufficient power has to be provided to generate even the first needle pulse in the right height). It might happen that the circuit will not start oscillating which will of course cause a failure behavior.

This behavior is a known fact from the development time of the instrument and has also been reproduced recently with a RPCMAG prototype unit at IGEP TU-BS using a "soft" power supply. The failure did, however, not occur if the supply voltages were switched on and connected instantaneously using a relais.

The failure source can not be located definitely, but with the utmost probability, a catenation of unfortunate circumstances lead through a faulty oscillation of the resonant circuit in the sensor excitation drive. This is an absolutely uncritical error which can be corrected by a repeated Power off/on cycle.

The best modus operandi for RPCMAG would of course be to switch the instrument on, ensure that it works nominally, and leave it in the powered state to minimize the power on cycles.
