R O S E T T A
FLIGHT REPORTS
of RPC-MAG

RO-IGEP-TR-0015

Anomaly Report & Analysis

MAG-OB Failure in June 2005

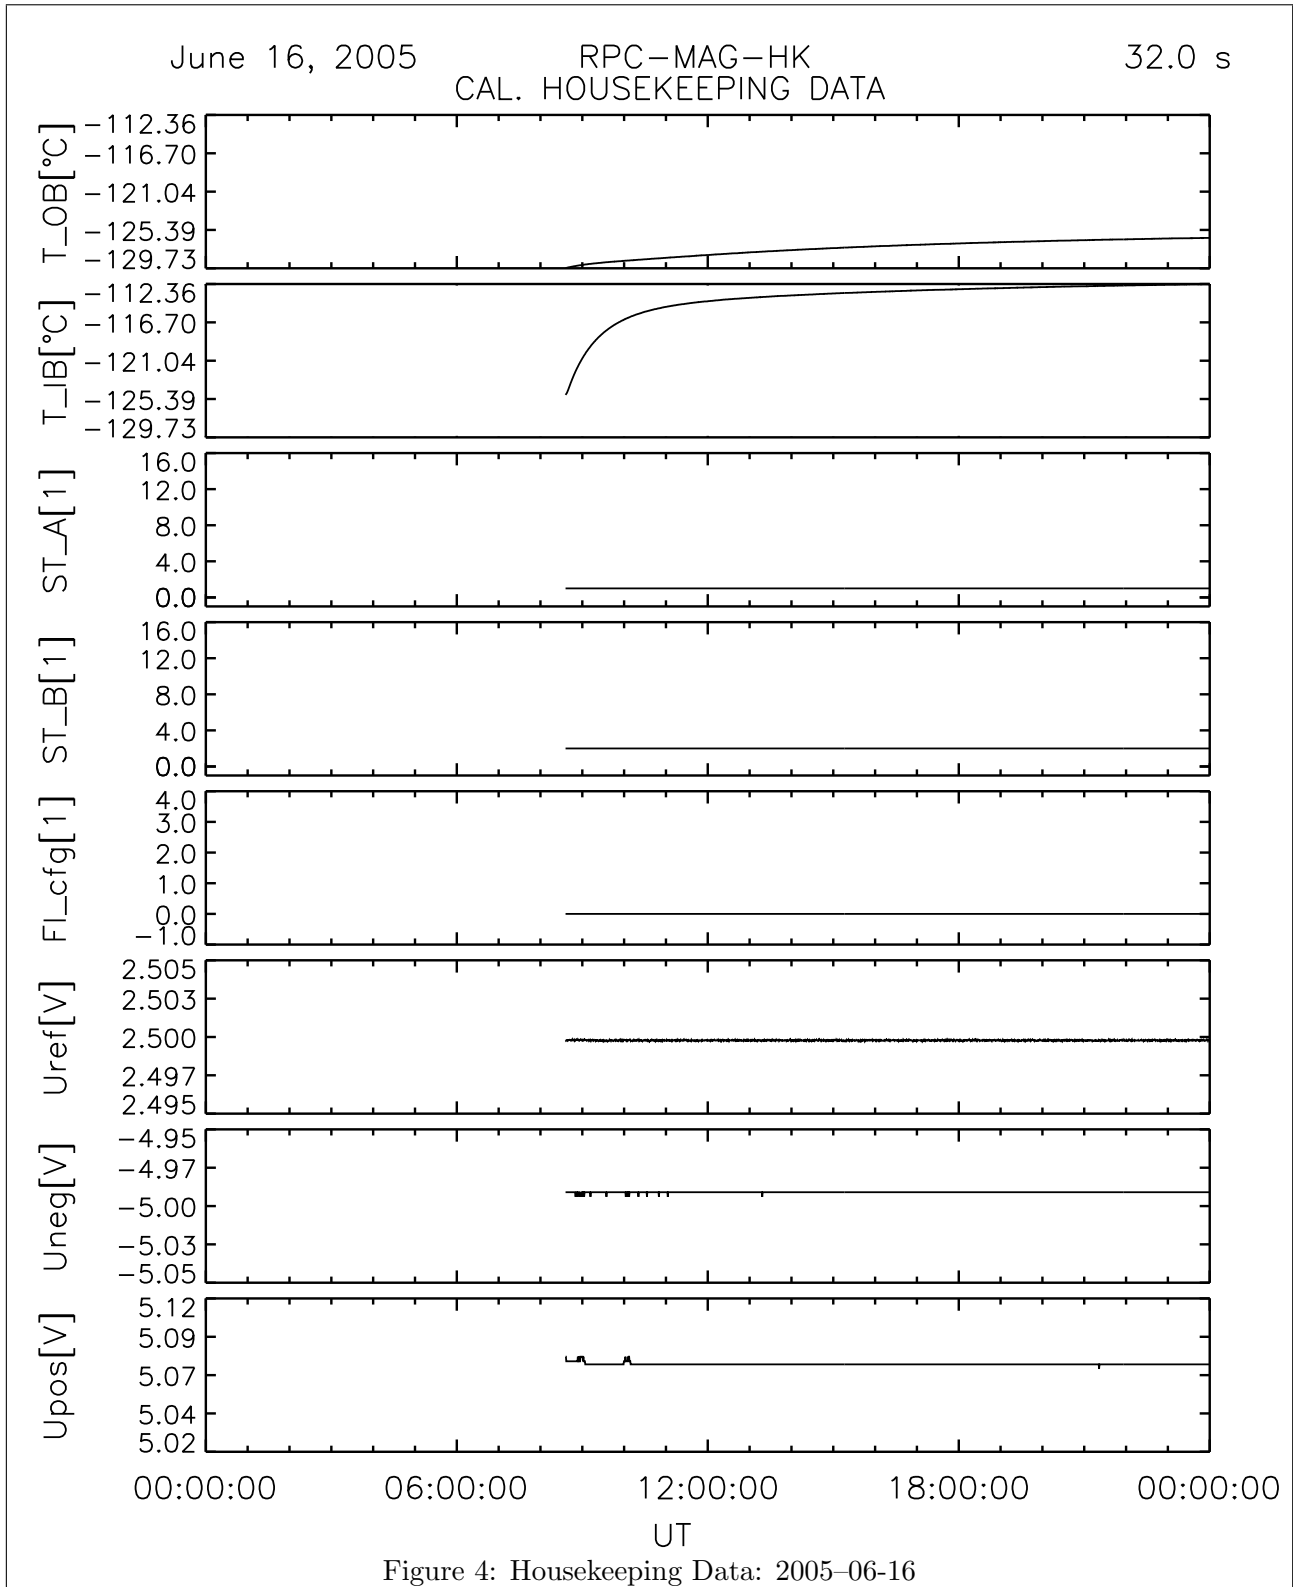
Figure 3: RPCMAG: Magnetic field measured with the OB Sensor

On the first view everything looked nominal. According to our HK data all necessary voltages had the right values (refer to the plots in Appendix B) and the RPC-MAG IB sensor transmitted reasonable data in the usual manner (refer to Figure 2). The OB sensor, however, sent a faulty signal (refer to Figure 3):
